RESULTS AND INTERPRETATION OF ROCK ANCHOR TEST PROGRAM

EXISTING LOCKS AND DAM NO. 26
MISSISSIPPI RIVER, ALTON, ILLINOIS

Woodward-Clyde Consultants
Chicago, Illinois

15 July 1979

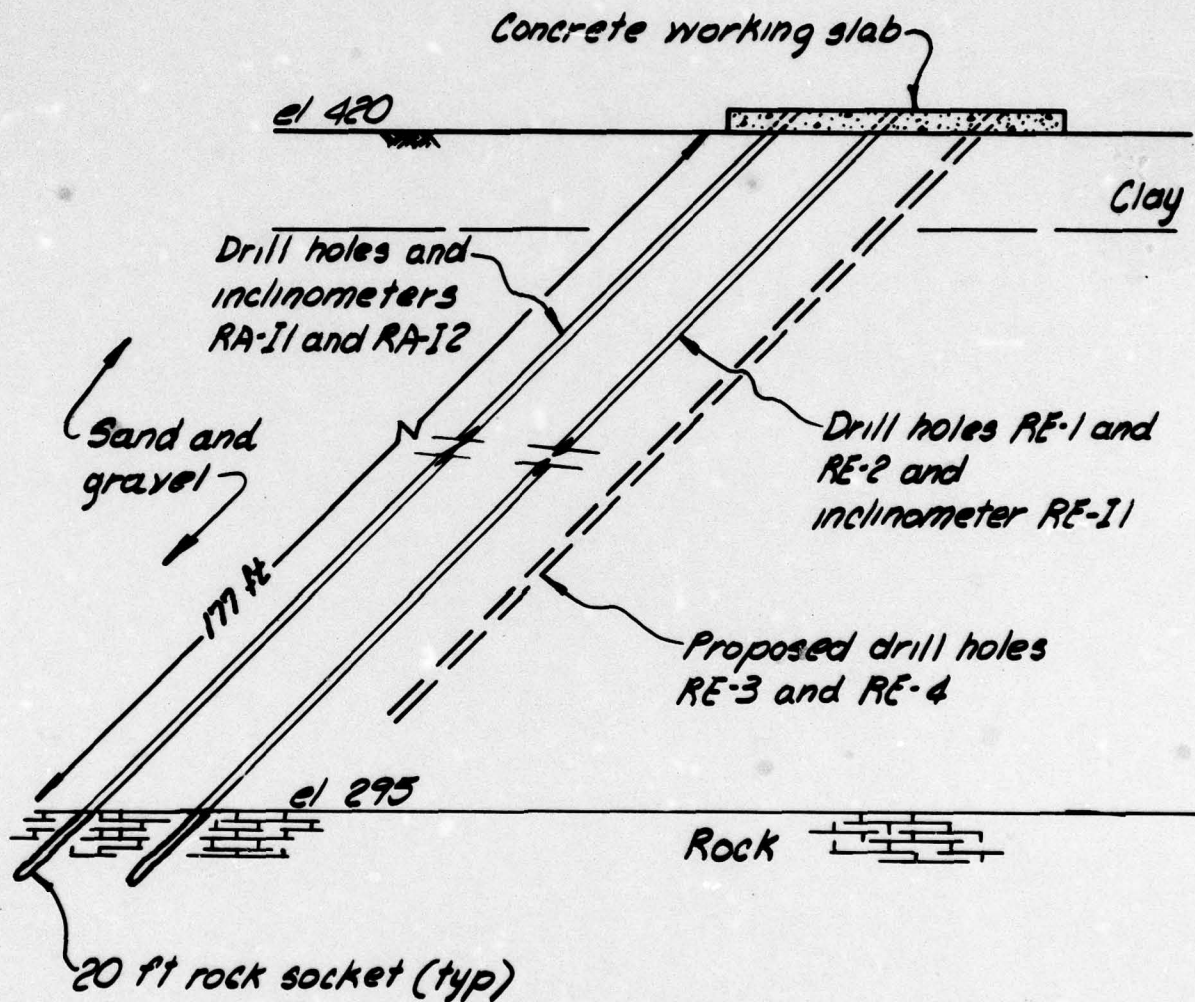
ROCK ANCHOR TEST PROGRAM	
SECTION AT DRILLING EFFECTS TEST	
FOUNDATION INVESTIGATION AND TEST PROGRAM EXISTING LOCKS AND DAM No. 26 ST LOUIS DISTRICT, CORPS OF ENGINEERS. DACW43-75-C-0000

The drilling effects test consisted of drilling four holes at 9-ft spacing and at an inclination of 45 degrees. As the test drill holes were successively drilled, the effects of drilling on the surrounding soil mass were assessed by various methods. The quantity of cuttings expelled from the drill holes was measured periodically and compared to the theoretical quantity calculated on the basis of the theoretical volume of the hole and the measured in situ unit weight of the soil. The ground deformation caused by drilling was periodically assessed on the basis of ground instrument (vertical and inclined inclinometers, and various types of surface and deep settlement points) measurements. The overall drilling effects were also assessed by measuring changes on in situ soil properties before and after drilling; a static cone penetrometer was used for this purpose.

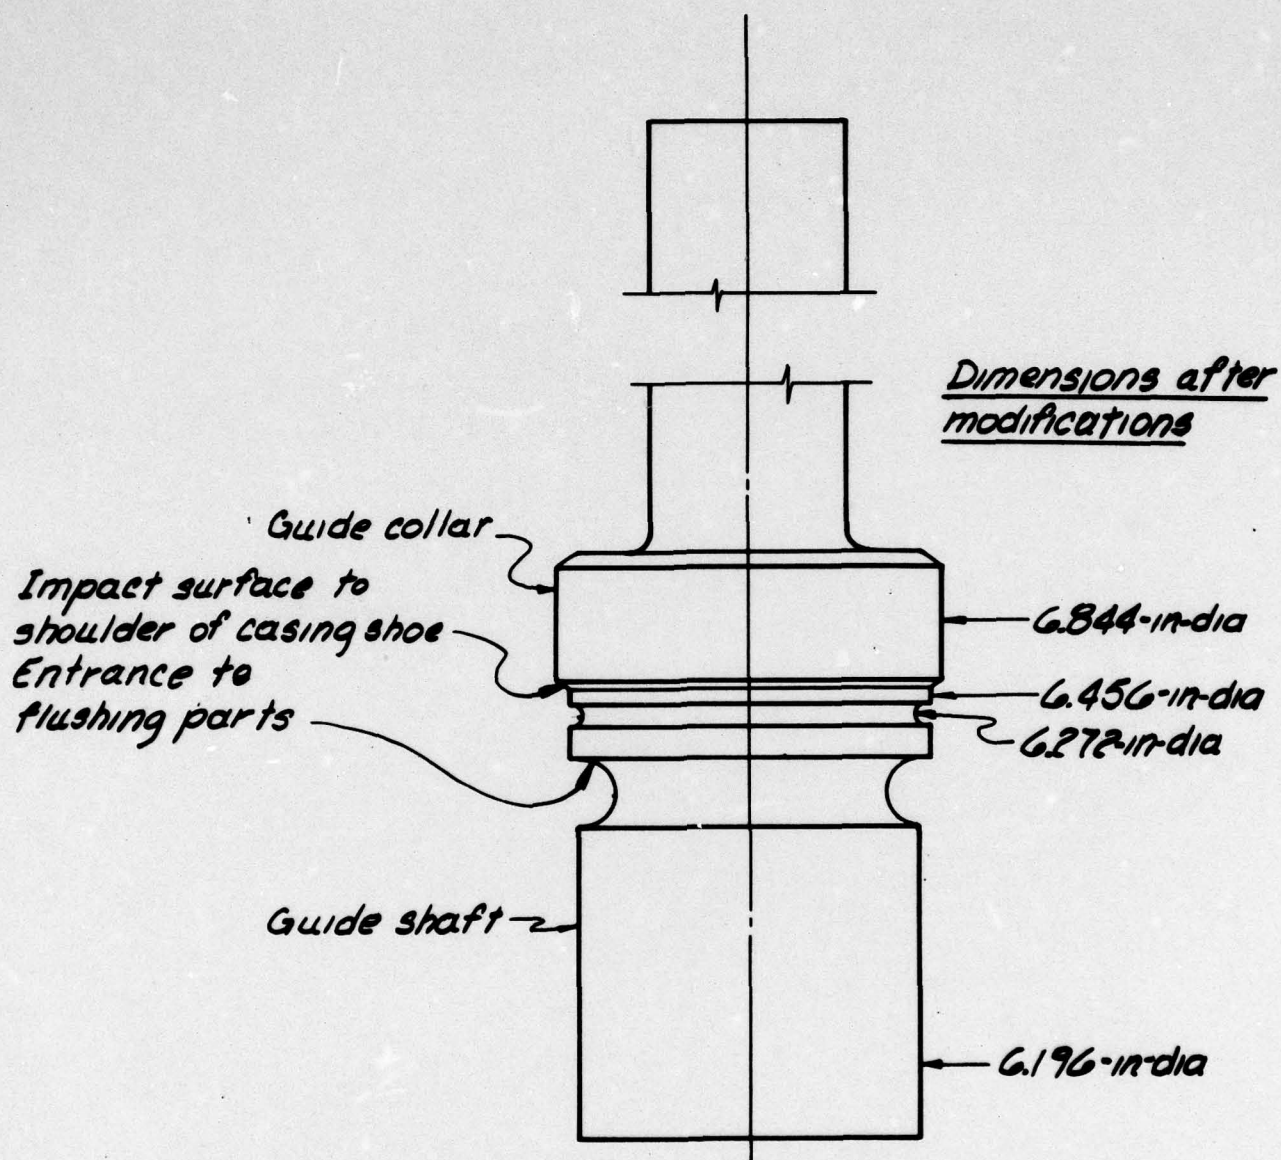
Note:
All surfaces are re-case hardened
after modification

ROCK ANCHOR TEST PROGRAM	
MODIFIED ODEX 165 GUIDE FOR US SIZE CASING	
FOUNDATION INVESTIGATION AND TEST PROGRAM EXISTING LOCKS AND DAM No. 26 ST LOUIS DISTRICT, CORPS OF ENGINEERS. DACW43-75-C-0002	
Woodward-Clyde Consultants VTC626 Phase III	Fig. 5.3

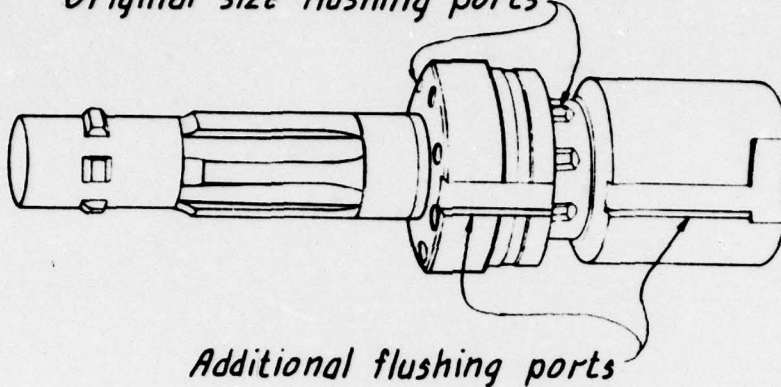
Original size flushing ports

Additional flushing ports

ROCK ANCHOR TEST PROGRAM

MODIFIED ODEX 165 GUIDE
FLUSHING PORTS

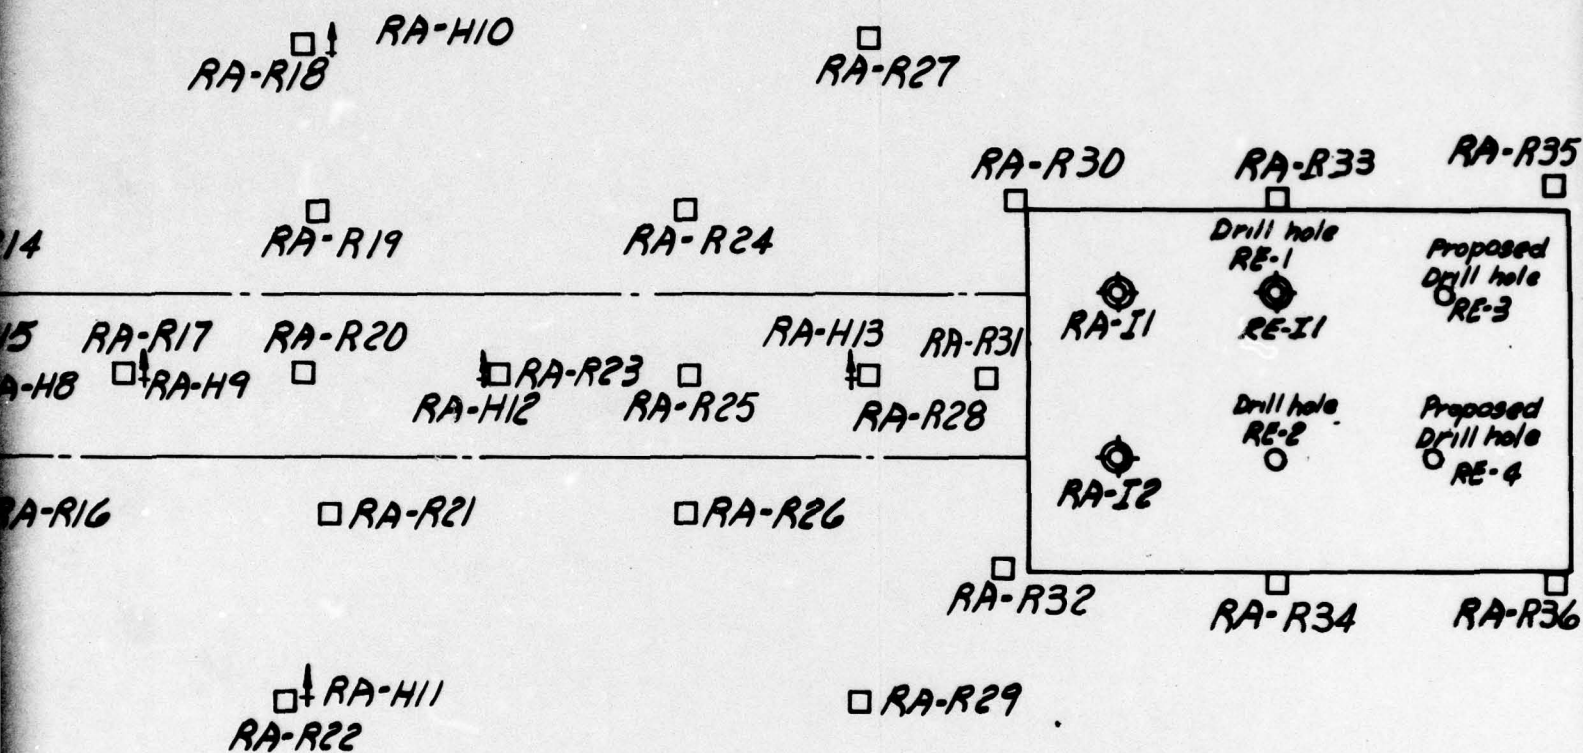
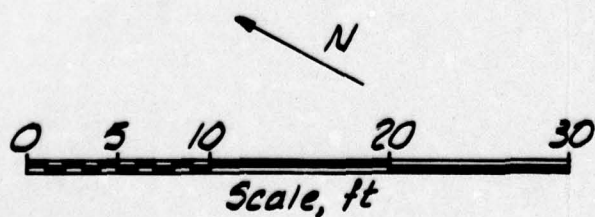
ROCK ANCHOR TEST PROGRAM	
LAYOUT OF GROUND INSTRUMENTATION	
FOUNDATION INVESTIGATION AND TEST PROGRAM EXISTING LOCKS AND DAM NO. 28 ST LOUIS DISTRICT, CORPS OF ENGINEERS. DACW43-76-C-0000	
Woodward-Clyde Consultants V7C020 Phase II	Fig. 5.5

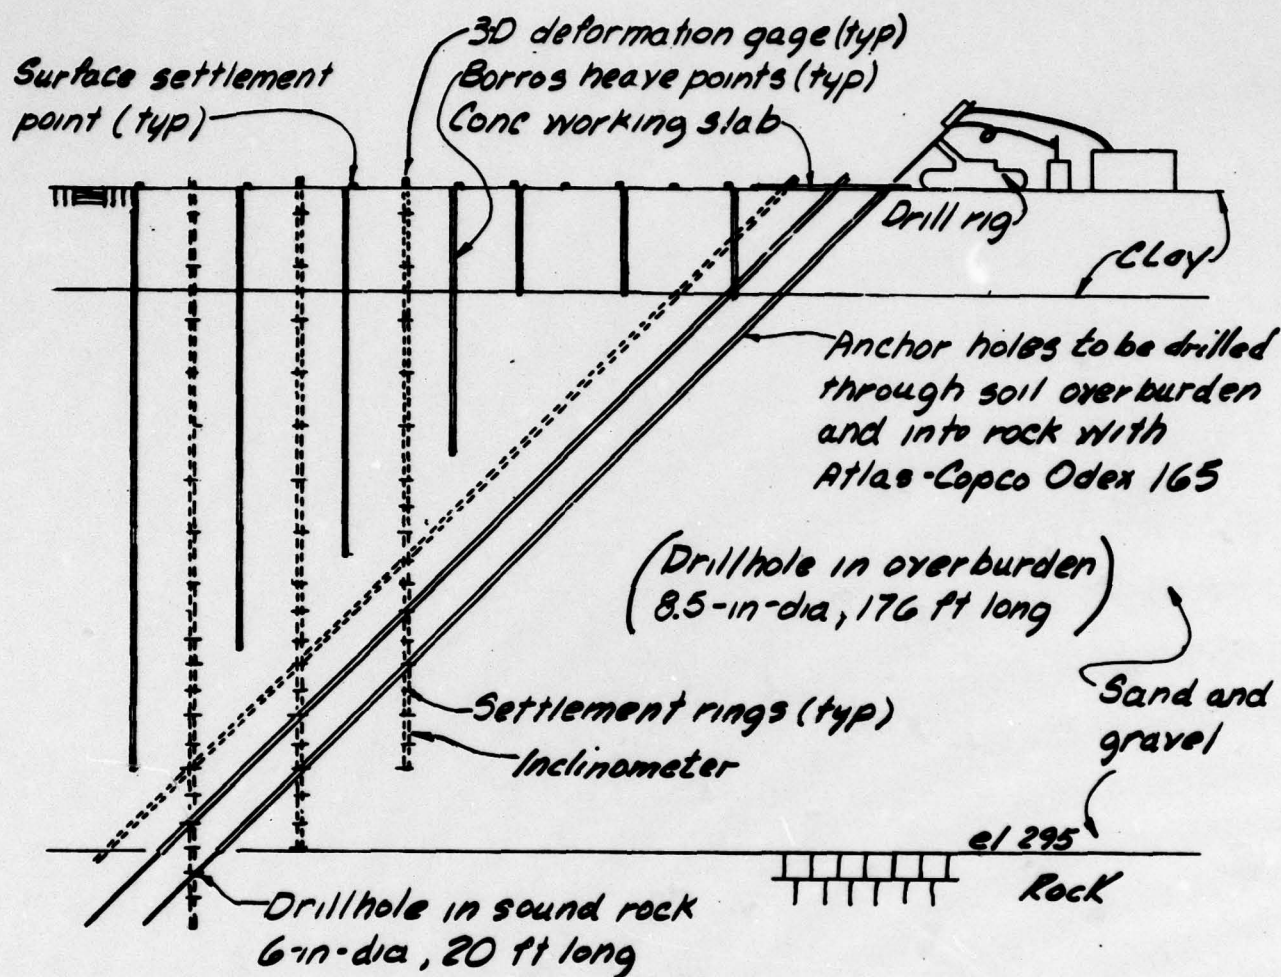
Woodward-Clyde Consultants</p> <p>VTG025 PHOTO IX</p>	<p>Fig. 5.6</p>

Note:
Inclinometer installed
in completed anchor holes
RA-I, RA-I2, and RE-1

<p>ROCK ANCHOR TEST PROGRAM</p> <p>SECTION OF</p> <p>GROUND INSTRUMENTATION</p>	
<p>FOUNDATION INVESTIGATION AND TEST PROGRAM</p> <p>EXISTING LOCKS AND DAM No. 26</p> <p>ST LOUIS DISTRICT, CORPS OF ENGINEERS.</p> <p>DACW43-78-C-0008</p>	
<p>

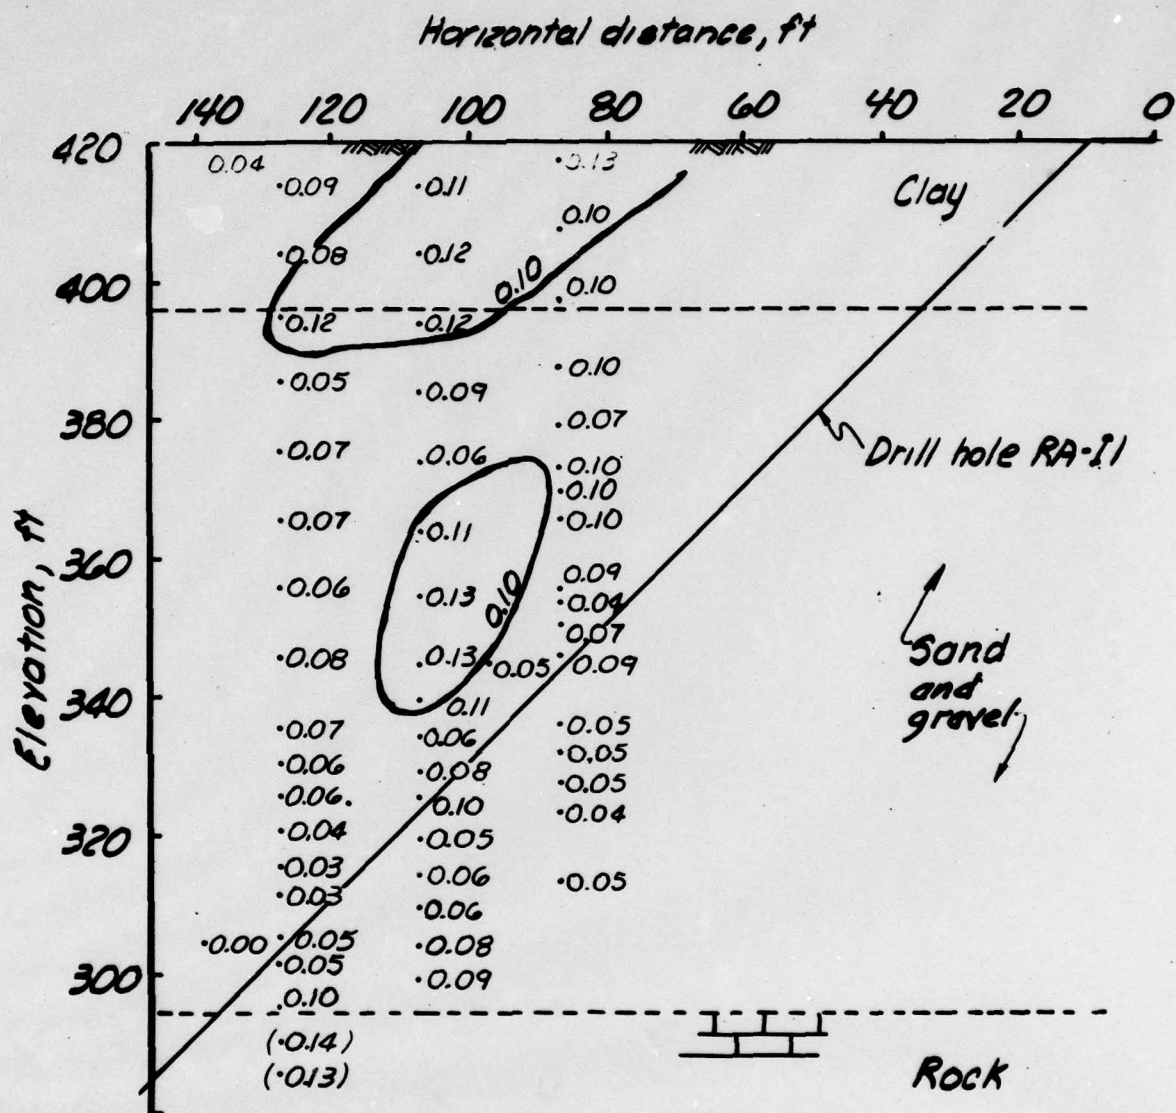
- (1) Settlement values are in, feet
- (2) Settlement data from surface reference points, boros points and sondex

ROCK ANCHOR TEST PROGRAM	
GROUND SETTLEMENT AFTER DRILLING RA-11	
FOUNDATION INVESTIGATION AND TEST PROGRAM EXISTING LOCKS AND DAM No. 26 ST LOUIS DISTRICT, CORPS OF ENGINEERS. DACW43-72-2-001	
Woodward-Clyde Consultants V: C626 Phase II	Fig. 5.7

Ground deformation resulting from loss of ground was large: maximum observed ground settlement was 0.4 ft at a depth of 80 ft below ground surface. Corresponding maximum ground surface settlement was 0.23 ft. Large lateral soil deformation was also observed.

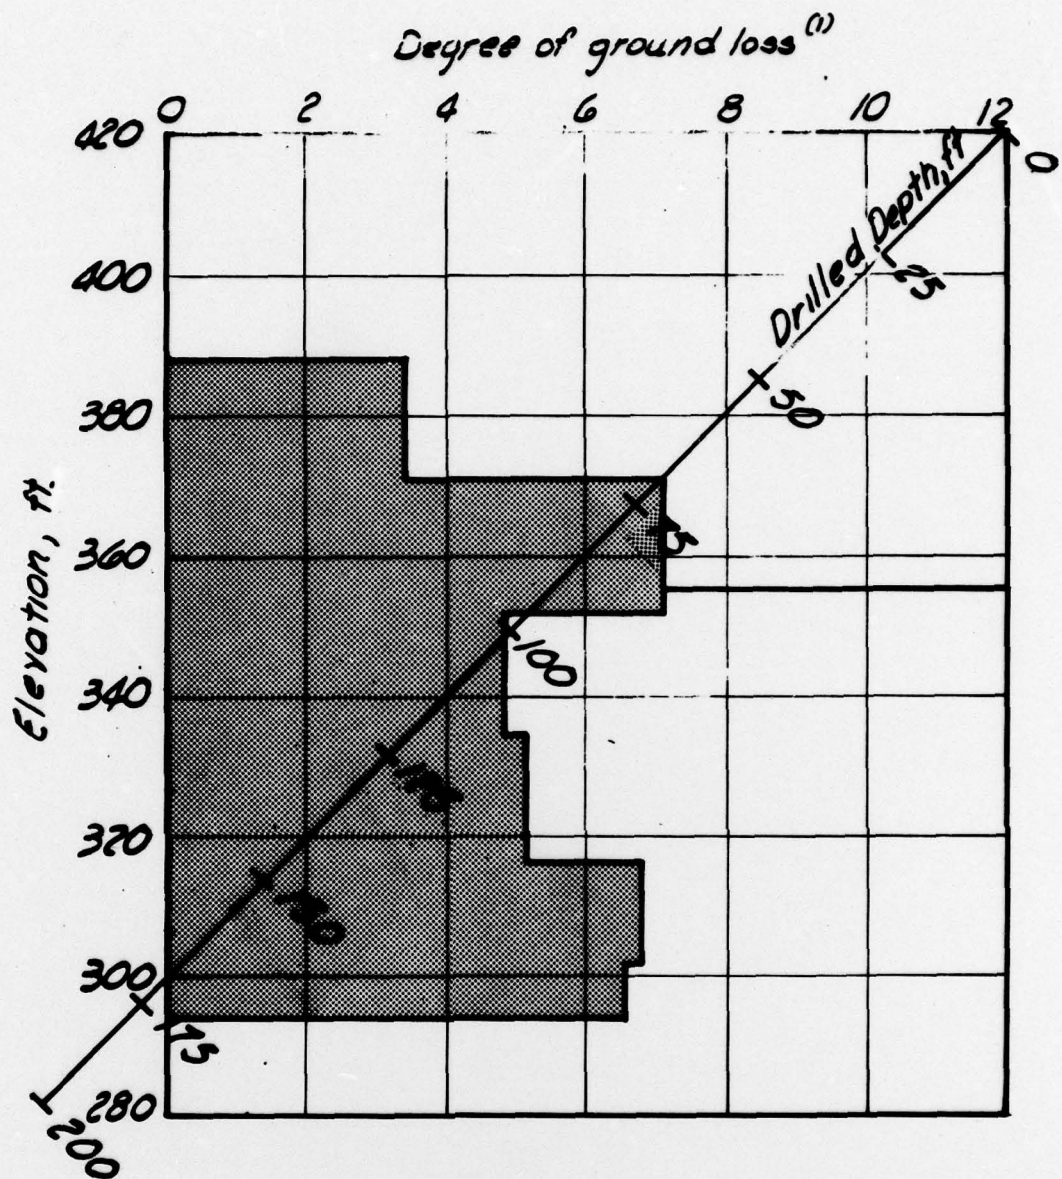
(1) Degree of ground loss = $\frac{\text{Measured volume of cuttings expelled from drill hole}}{\text{Theoretical volume of drill hole}}$

- (a) large loss of ground (2 to 5 times the theoretical volume of the drill hole) was observed during drilling. Most loss of ground was inherent to the system which consisted of advancing a casing and flushing soil cuttings using a large volume of compressed air;

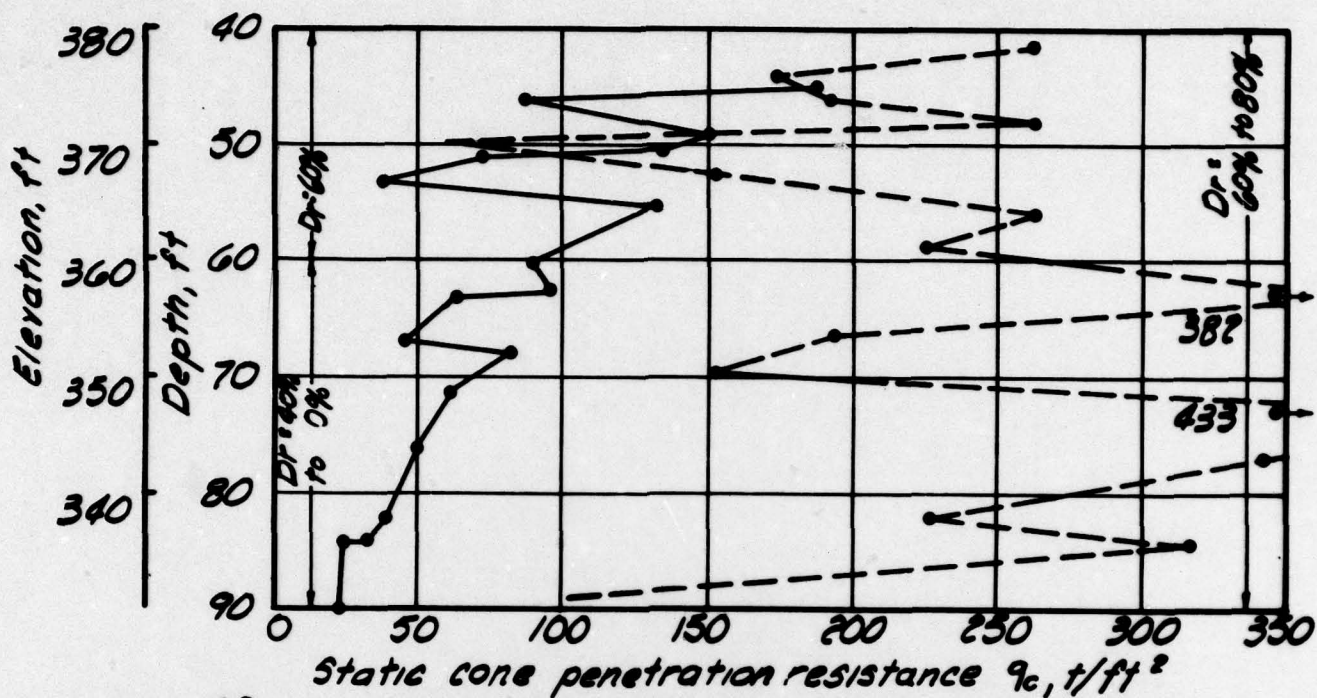
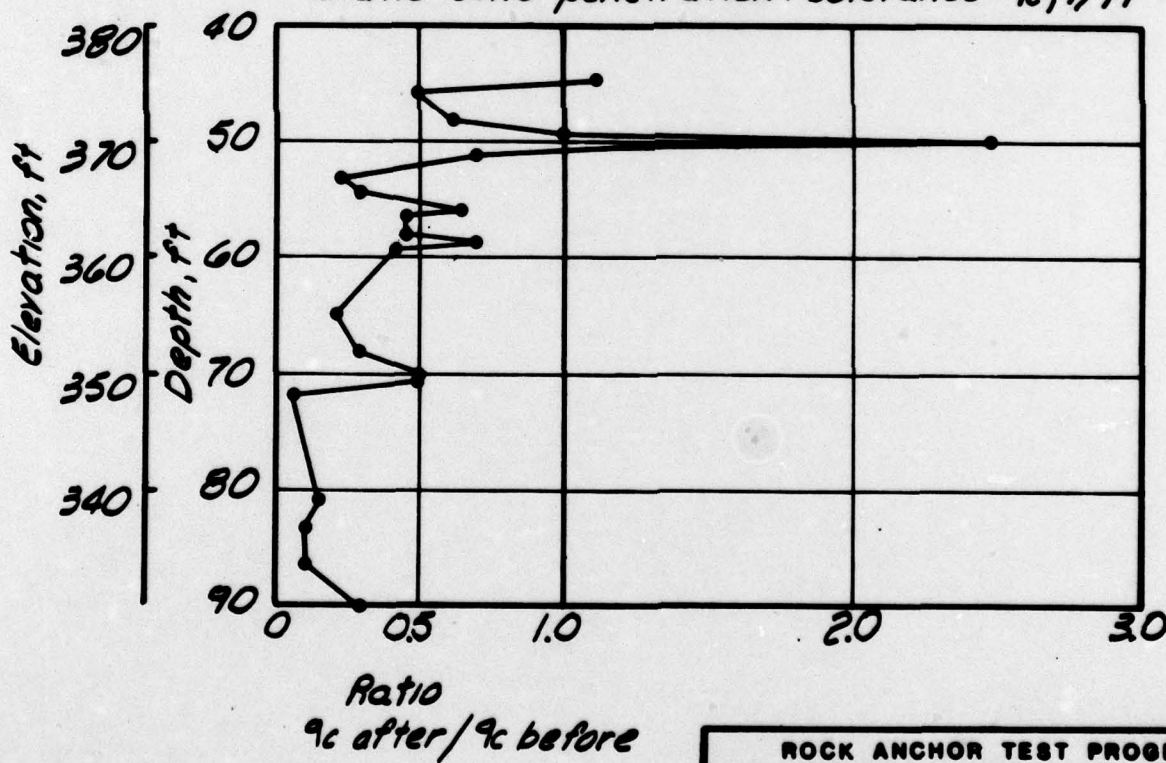
Legend
 --- Before anchor installation
 --- Boring DP-C1
 --- After anchor installation
 --- Boring RA-C1

**ROCK ANCHOR TEST PROGRAM
 COMPARISON BETWEEN STATIC
 CONE PENETRATION RESISTANCE
 BEFORE AND AFTER
 ANCHOR INSTALLATION**
